Use of Solventum™ Veraflo™ Therapy and Solventum™ V.A.C.® Therapy in the Management of Fournier's Gangrene

Misael C. Alonso, MD, FACP, CWSP, FAPWCA

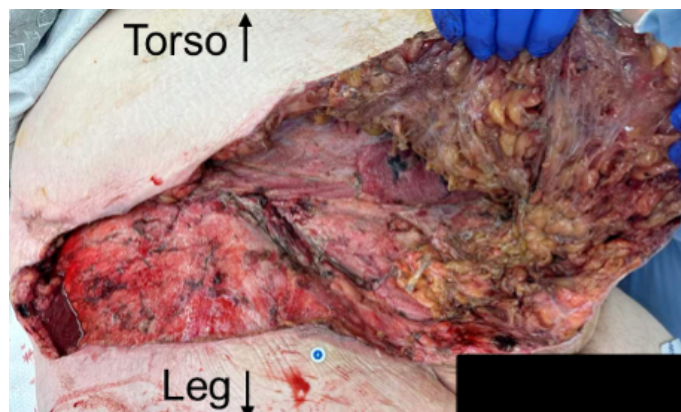
Figure 1. Appearance of the abdominal wound after surgical debridement. Image courtesy of Misael C. Alonso, MD, FACP, CWSP, FAPWCA

On Day 1, the patient underwent irrigation and debridement of the right groin and abdominal wall (**Figure 1**), followed by application of Veraflo Therapy. On examination, the wound measured 22.2 cm in length, 47.3 cm in width, and 12.0 cm in depth, with exposed necrotic muscle and necrotic subcutaneous

adipose tissue. A large volume of serous drainage with a mild odor was noted, and the wound bed demonstrated 1–25% slough. The periwound skin exhibited edema and erythema and showed clinical signs and symptoms consistent with infection. Both systemic and topical antibiotics were prescribed.

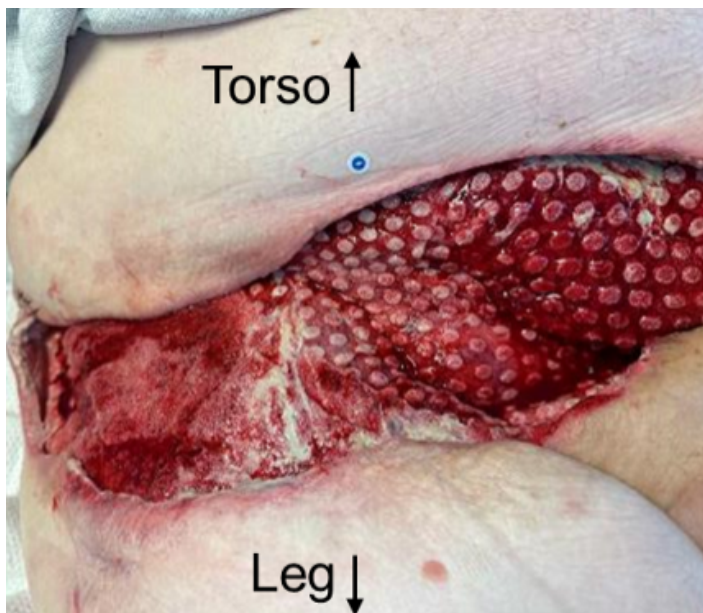
Figure 2 . Wound appearance on Day 19 after treatment with Solventum™ Veraflo™ therapy using the Solventum™ Veraflo™ Cleanse Choice™ Dressing and surgical debridement. Image courtesy of Misael C. Alonso, MD, FACP, CWSP, FAPWCA

Veraflo therapy was reapplied and administered using two V.A.C.® Ulta Therapy Units that were synchronized to function simultaneously. Large Solventum™ Veraflo Cleanse Choice™ Dressings were applied to the wound bed. No changes were made to the therapy parameters or dressing change frequency. Veraflo therapy was continued for 19 days. At each dressing change, surgical debridement was performed, followed by reapplication of Veraflo Therapy using the Veraflo Cleanse Choice Dressings using the same therapy parameters and dressing change frequency. By Day 19, the wound demonstrated marked improvement, with granulation tissue formation observed (**Figure 2**). At this time, wound dimensions measured 13.13 cm in length, 32.24 cm in width, and 5.8 cm in depth.

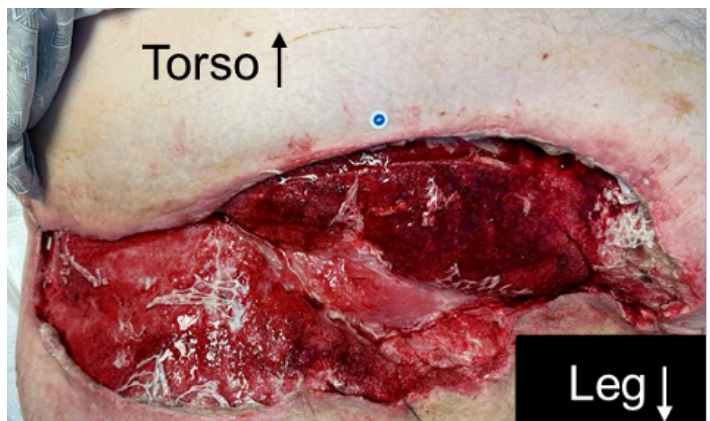
Figure 3 . Wound appearance on Day 26, (5 days after allograft application). Image courtesy of Misael C. Alonso, MD, FACP, CWSP, FAPWCA

On Day 26, V.A.C.® Therapy was continued, and the patient reported he was doing well. At this time, wound dimensions measured 14.1 cm in length, 34.5 cm in width, and 8.5 cm in depth (**Figure 3**). Circumferential undermining was noted, extending from the 3:00 to 9:00 position measuring 6.2 cm, as well as additional undermining from the 9:00 to 3:00 position with a maximum distance of 3.8 cm. A moderate amount of sanguineous drainage was noted without associated odor. The patient reported no wound-related pain, consistent with an insensate wound. The wound bed continued to demonstrate favorable healing characteristics, with 76–100%, bright red granulation tissue, 1–25% slough, and 1–25% epithelialization. The periwound skin exhibited edema, scarring, and erythema; however, no clinical signs or symptoms of infection were observed.

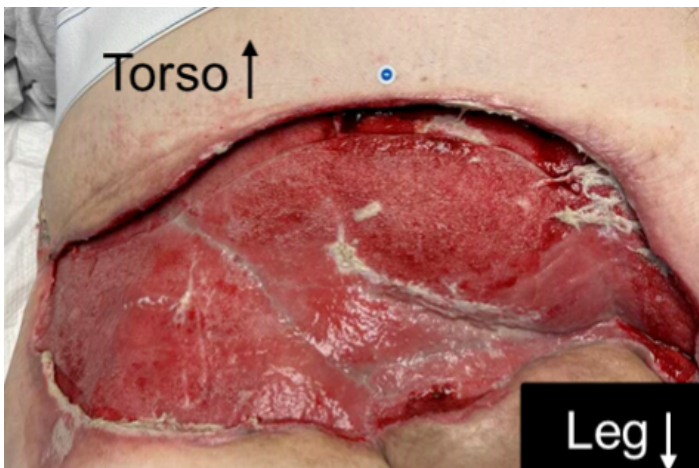
Figure 4 . Wound appearance on Day 36 (10 days after allograft application). Image courtesy of Misael C. Alonso, MD, FACP, CWSP, FAPWCA

On Day 36, a non-contact, real-time fluorescence imaging was performed to assess the presence and location of pathogenic bacteria in the wound bed and periwound area. Fluorescence imaging demonstrated red fluorescence within the wound bed and periwound tissues, consistent with a high bacterial burden exceeding 10^4 colony forming units/gram (CFU/g). The patient subsequently underwent sharp debridement, with removal of adipose tissue, dermis, epidermis and subcutaneous tissue along with devitalized tissue, biofilm, exudate, fibrin and slough. Fluorescence imaging was repeated post-cleansing and debridement and demonstrated reduction or elimination of pathogenic bacteria confirmed by the absence of red or cyan fluorescence signals. Post debridement wound measurements were 18.1 cm in length, 35.3 cm in width, and 2.2 cm in depth (Figure 4). Undermining was noted from the 3:00 position to the 9:00 position with a maximum distance of 2 cm, with additional undermining from the 9:00 position to the 3:00 position, with a maximum distance of 1.1 cm. A moderate amount of sanguineous drainage was noted with no associated odor. Following completion of debridement and reassessment, V.A.C.[®] Therapy was reapplied.

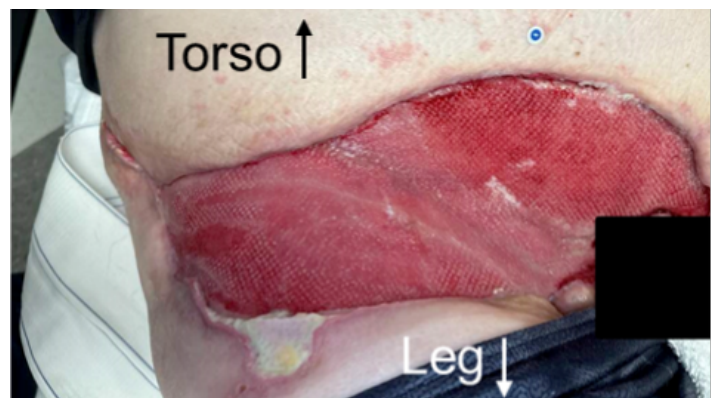
Figure 5 . Wound appearance 48 days after presentation. Image courtesy of Misael C. Alonso, MD, FACP, CWSP, FAPWCA

At outpatient follow-up on Day 48, the wound measured 12.2 cm in length, 29.6 cm in width, and 0.3 cm in depth, with 0.8 cm of undermining (Figure 5). The patient declined surgical closure and hyperbaric oxygen therapy. Consequently, the wound was left to heal by secondary intention.

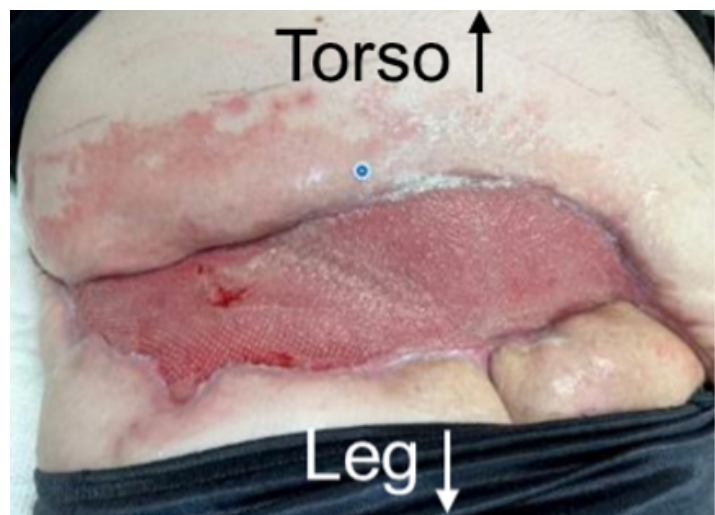
Figure 6 . Wound appearance 76 days after presentation. Images courtesy of Misael C. Alonso, MD, FACP, CWSP, FAPWCA

On Day 76, the patient underwent surgical debridement. The wound measured 9.3 cm in length, 30.5 cm in width, and 0.2 cm in depth (Figure 6). Given the degree of wound improvement, V.A.C.[®] Therapy was discontinued. Standard wound care dressings were initiated, with dressing changes performed once per week. Approximately 2.5 months after presentation, the wound measured 5.2 cm in length, 22.6 cm in width, and 0.1 cm in depth, with re-epithelialization observed (Figure 7). The wound continued to demonstrate healing by secondary intention (Figure 8). At approximately 11 months after presentation, wound closure had sufficiently progressed, and the patient was discharged from the wound care clinic.

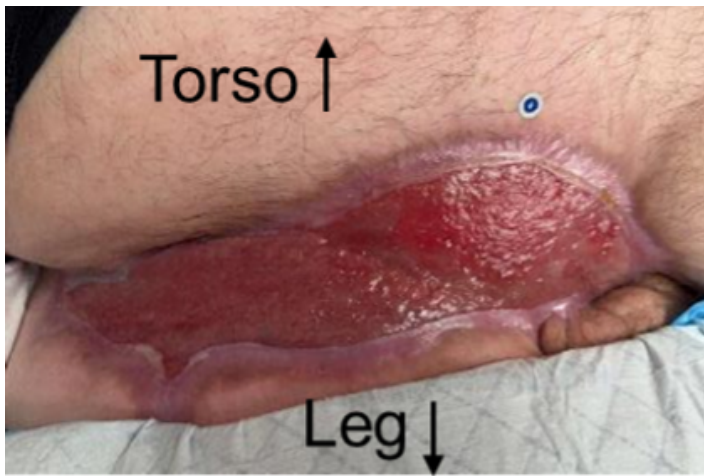
Figure 7 . Wound appearance after 77 days with standard wound care dressings (~2.5 months after presentation). Images courtesy of Misael C. Alonso, MD, FACP, CWSP, FAPWCA

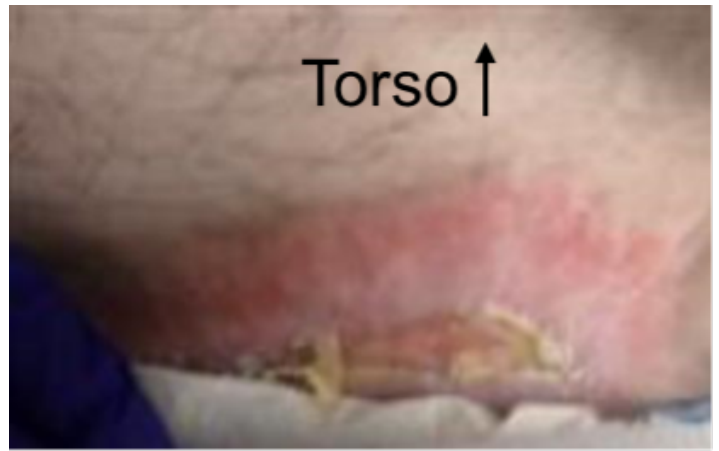
Figure 8 . Wound appearance approximately 11 months after presentation. Images courtesy of Misael C. Alonso, MD, FACP, CWSP, FAPWCA
