Fistula Isolation Device, Ostomy Appliance and Negative Pressure Wound Therapy Use in a Hostile Abdomen

Kersten E. Reider RN, BSN, CWOCN

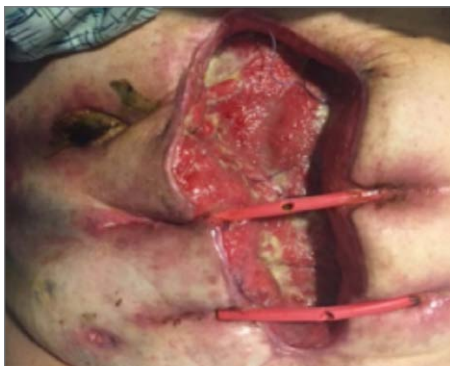
Figure 1: Necrotic stoma with tunneling under intact skin into abdominal wound. 18 x 10.5 x 3.3cm

assessed by the WOCN. It was noted that her abdominal wound was packed with betadine soaked gauze and her stoma showed signs of ischemia. On post op day six the surgeon requested the wound be treated with NPWT. Upon assessment of the abdominal wound, there were retentions sutures in place, the wound base was red, concerns for fascial breakdown, and increase serosanguinous drainage noted. The ostomy appliance contained dark, liquid effluent. At this time, NPWT was applied to the wound utilizing white foam to the wound base followed by black foam with negative pressure at 75mmHg to promote granulation tissue. A two piece stretch to fit wafer with drainable bag was applied to the ostomy. This treatment plan was continued for approximately four days until feculent drainage was noted in the JP drain in the patient's right lower quadrant. Was this a questionable enterocutaneous fistula from a previous placed JP drain? The decision was made to discontinue NPWT and pack the abdominal wound with Dakin's infused gauze packings until further assessment could be accomplished.

Over the course of ten days, the wound continues to be packed with Dakin's infused gauze, the stoma continues to deteriorate causing the ostomy appliances to leak frequently, and a connection between the ostomy and wound is noted. Assessment by the WOCN revealed a necrotic stoma that retracted into a skin fold with a circumferential mucocutaneous separation. Upon further assessment, it was noted that the effluent from the stoma was tracking under intact skin and pooling in the base of the abdominal wound (Figure 1). The wound measured 18 X 10.5 x 3.3 with a 4cm tunnel at 9:00, at this time the decision was made by the WOCN to try to wall off the connection between the stoma and abdominal wound to prevent effluent from entering the wound while promoting granulation tissue and wound contraction.

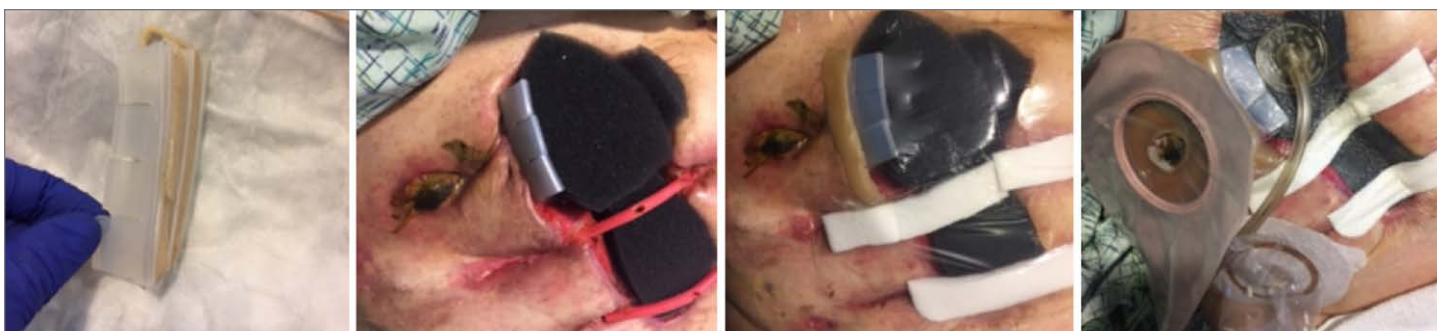
A fistula ISOLATOR STRIP® was cut and fit along the right lateral wound wall to keep the effluent from the stoma from entering the wound bed. NPWT was then placed utilizing white foam to the friable wound base and then filled with black foam at -100mmHg. (Figure 2). A convex ostomy appliance was placed over the stoma to contain effluent and a fecal containment device was placed over the old JP drain site to collect the feculent drainage. This particular treatment plan was continued for a few days until the patient returned to the operating room for drainage of an abdominal abscess that extended from the site of the old JP site into the right Iliac crest. While in the operating room, the surgeon had considered revising the patient's stoma that had retracted 2cm below skin level but unfortunately mobilization was not achieved. Now with a new surgically created wound in the right lower abdomen the WOCN decided to utilize NPWT to this area bridging to the midline abdominal wound. Over the next month the treatment plan consisted of utilizing a fistula ISOLATOR STRIP® to the right lateral wound wall to keep stoma effluent from entering the wound bed. At this point there was no concern for fistula development in the midline wound, and NPWT was applied to the wound base utilizing black foam with negative pressure at -100mmHg. During this period, there was production of granulation in the wound bed, the tunnel from the stoma to the wound had closed, and the wound edges had contracted significantly. All these positive patient outcomes led to the discontinuation of NPWT and application of a local wound dressing that could be managed by the patient or visiting nurses (Figure 3).

Figure 2: Application of Fistula ISOLATOR STRIP® and NPWT

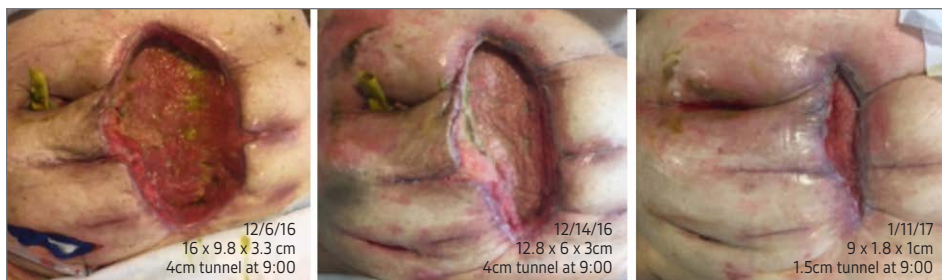
Figure 3: Progression of the wound utilizing a fistula ISOLATOR STRIP® and NPWT

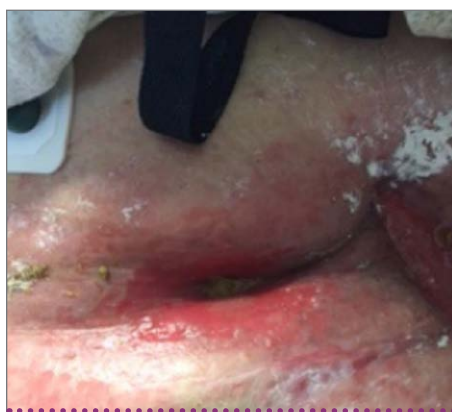
contain the effluent with no success. On average the ostomy appliances needed to be changed two to three times a day. Frequent leaking of the ostomy appliance caused the patient's peristomal skin to become severely denuded requiring intravenous pain medication for appliance changes (Figure 4). Leaking of the ostomy appliance became a barrier to the patient's discharge. The patient could not independently care for her ostomy appliance at home, rehab facilities had refused her admittance due to a complicated ostomy, visiting nurse associations felt she needed a higher level of care, and she did not meet the requirements for a skilled nursing facility. The WOCN was tasked with creating an appliance that would have an increase wear time, allow the patient to be more independent, and ultimately return home with visiting nurses. Assessment of the stoma revealed a

Figure 4: Denuded peristomal skin from leaking ostomy appliance and high output stoma

contracted stoma located in a skin fold with a circumferential mucocutaneous separation that was functioning for high output. Since the stoma resided in a skin fold, there needed to be some kind of conduit for the effluent to flow through and be directed into the ostomy appliance. A WOUND CROWN® was utilized as a conduit that was cut to fit around the stoma and fit snugly into the skin fold. The WOUND CROWN® was fit into a two-piece cut to fit ostomy appliance with a belt to ensure security (Figure 5). The use of the WOUND CROWN® proved to be successful. The ostomy appliance remained in place for two days with

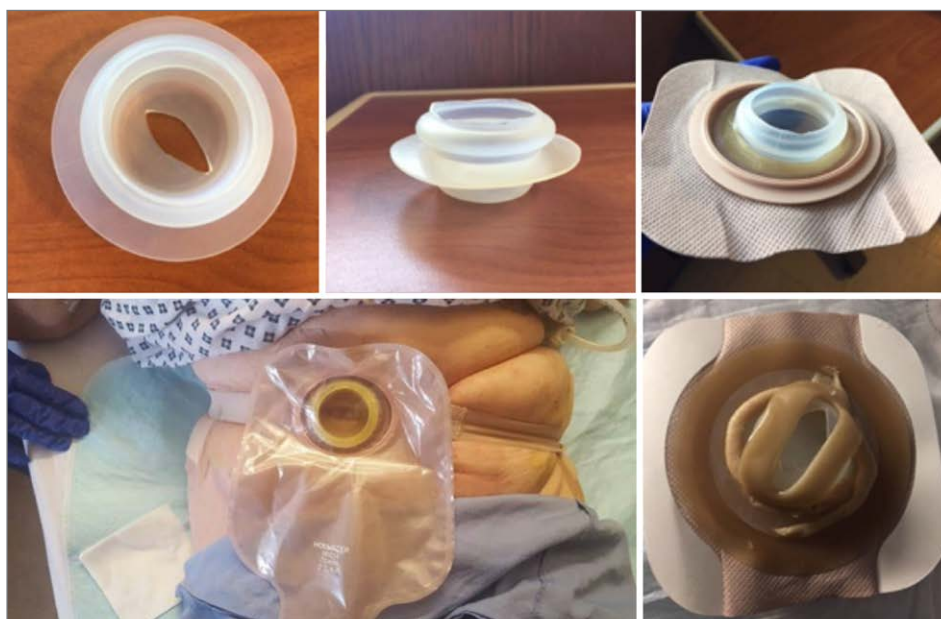
Figure 5: The utilization of the WOUND CROWN® as part of the ostomy appliance

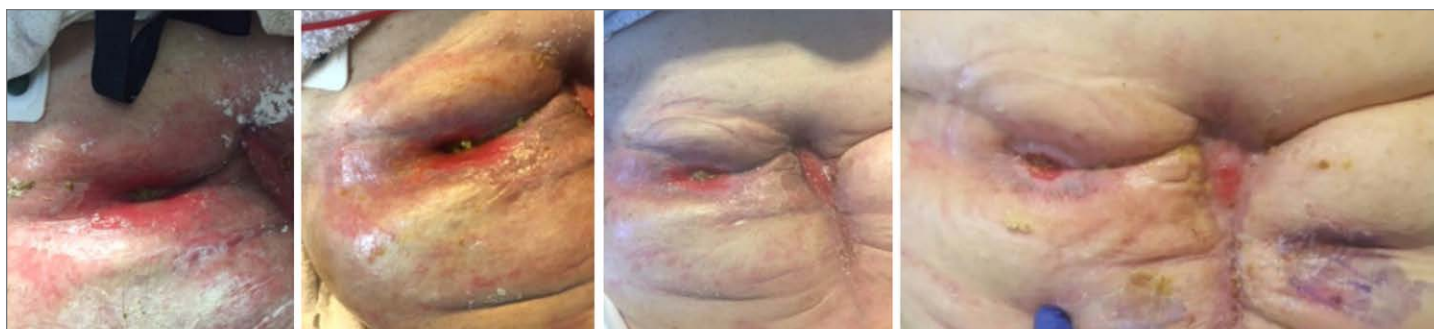
no leaking. Her peristomal skin significantly improved within two weeks which resulted in the reduction in pain medication consumption (Figure 6). Due to the complexity of the ostomy appliance application, visiting nurses along with the patient and family members were provided detailed bedside and written instructions so that the patient could return home upon discharge.

Figure 6: Progression of peristomal skin with the use of WOUND CROWN® and ostomy appliance
